Areas of Potential Concern

DESIGN PARAMETERS

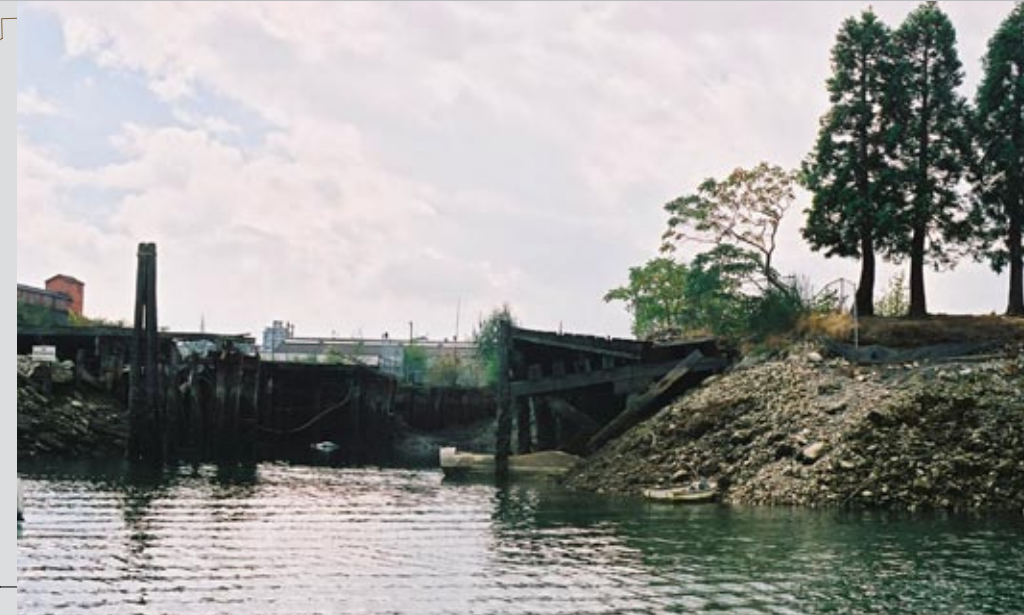
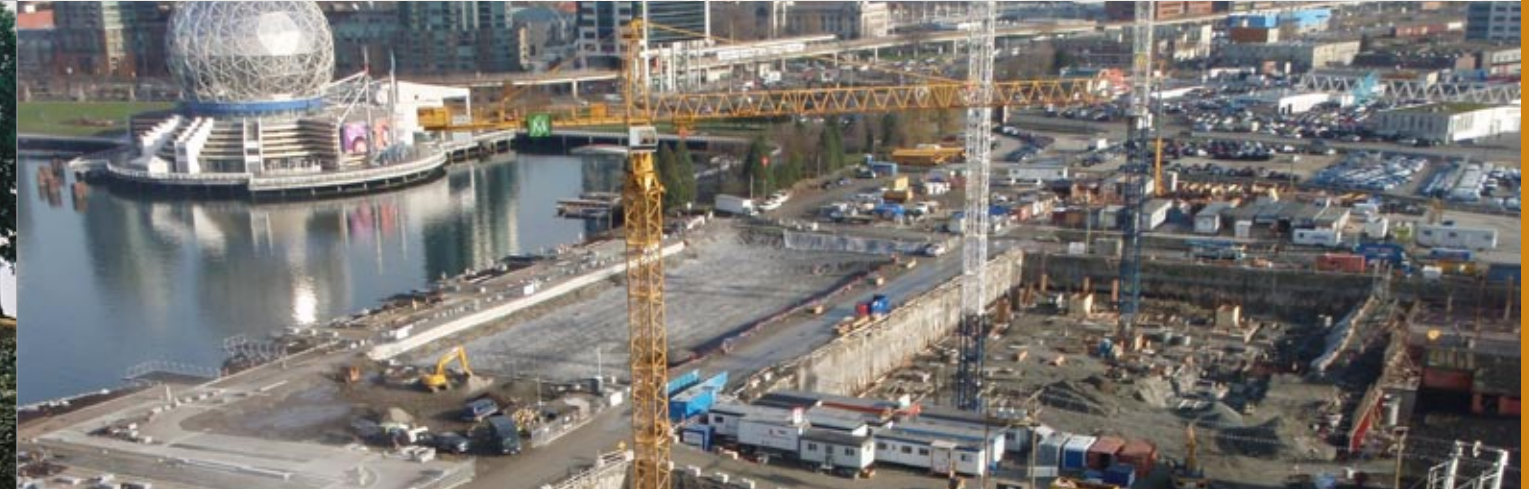
Diagram shows locations of test excavations used to identify areas of contamination. Below, waterfront before remediation. At right, jet grout walls are built to contain soils and prevent contact with the waters of False Creek.
